Property Inspection Report

Patrick Casey
Casey Premier Service LLC

123 East 110 ST
Inspection Prepared For: James Smith
Agent:

Date of Inspection: 1/29/2026
Year Built: 22 Years Size: 2100
Weather: Clear

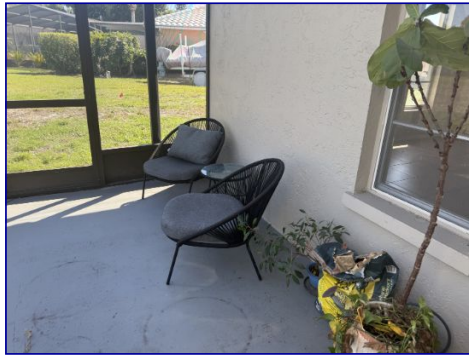
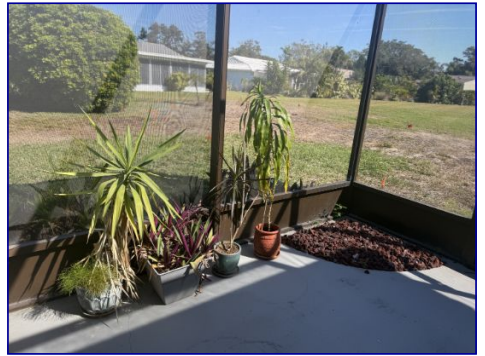
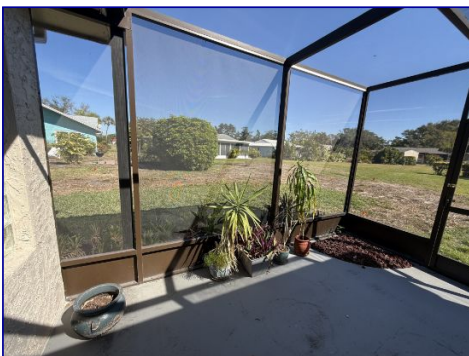
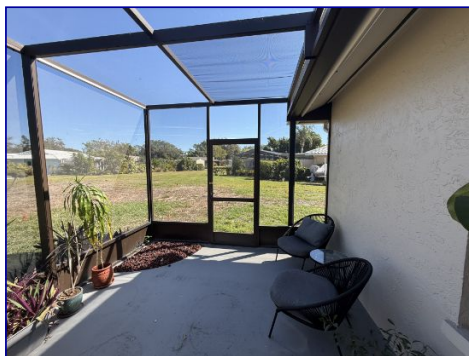
- Observations:
- Patio Door Bent. Will not close Completely.

Screen Door Bent bottom. Will Not Close.

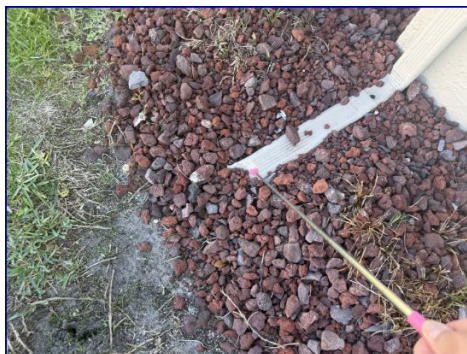
Damage on down spout NW Corner

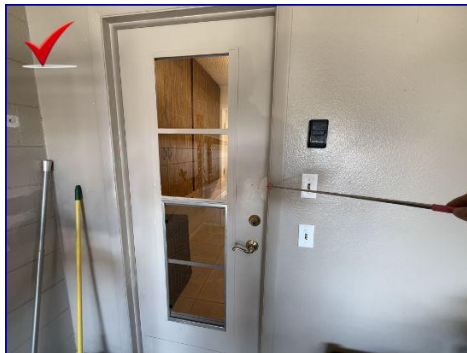
- The door between the house and the garage is not fire-rated. This is a safety concern. Recommend a qualified contractor install a proper fire-rated door between the garage and house.

No Fire Rating

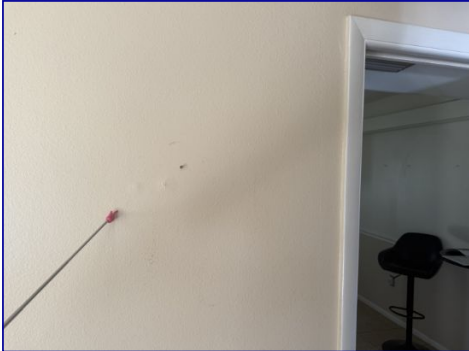
- Holes in walls

Screw Hole on Walls

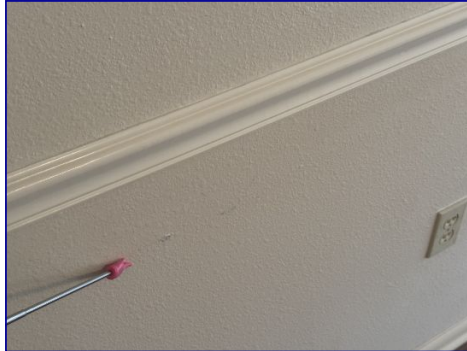
Wall Damage

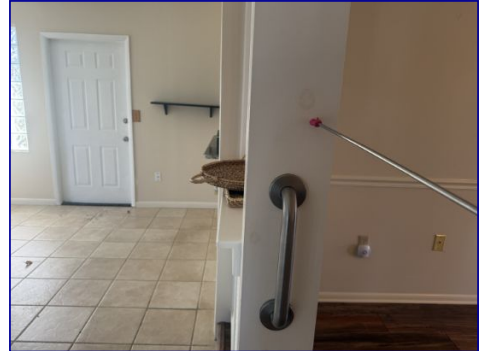
- There are stains on the walls. Monitor and repair as needed.

Stains

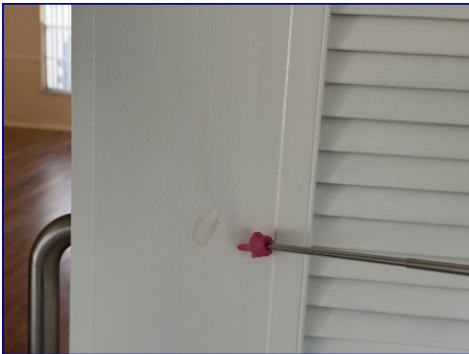
Stains

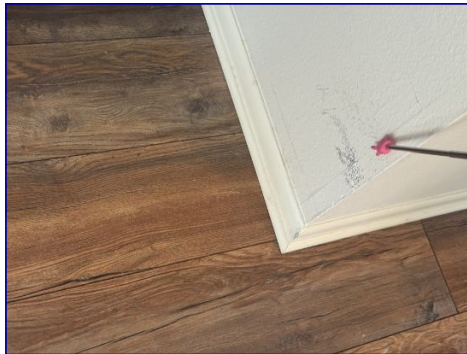
Damage at hallway

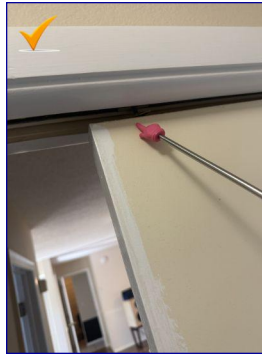
- Slider door is loose. Does not close completely.

Door Track Loose

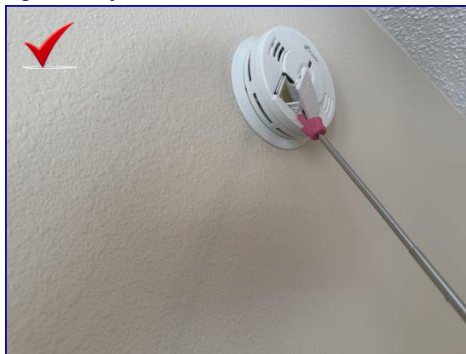
- Smoke detector not test/ Missing battery

Smoke Alarm missing battery

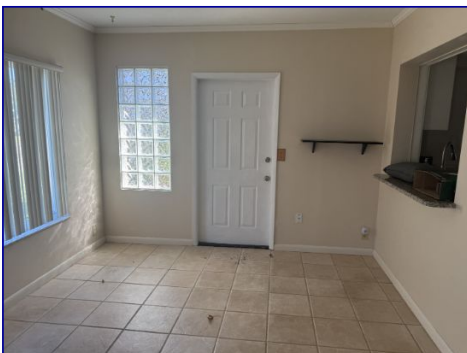
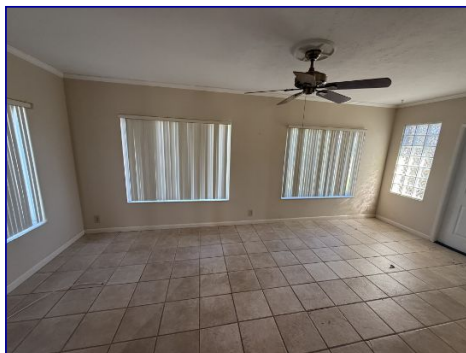
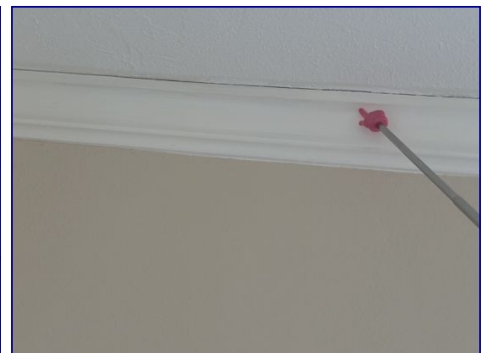
- Typical cracks
- Damage

Crown Board separating

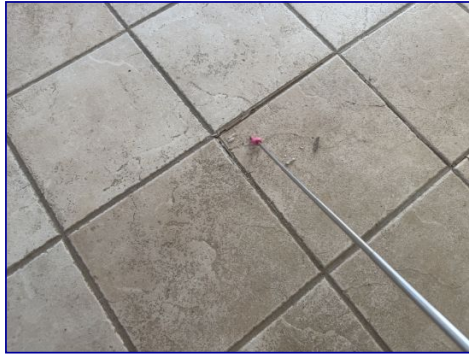
- The tile floor had some cracked/damaged tiles. Replace the tiles as needed.

Floor grout missing and cracking

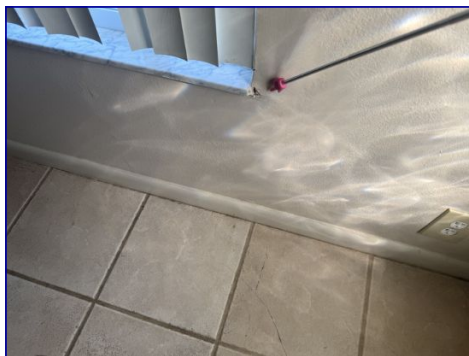
- Evidence of an active leak
- Evidence of an active leak

Signs of leaking

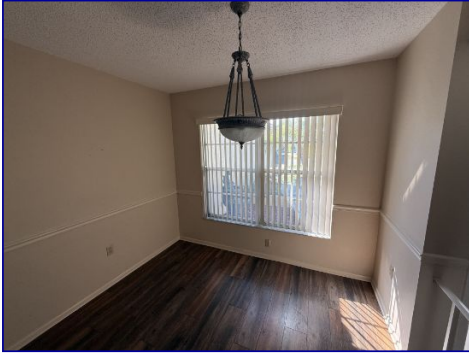
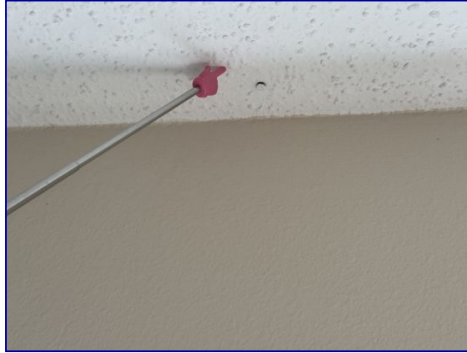
Nails popping down

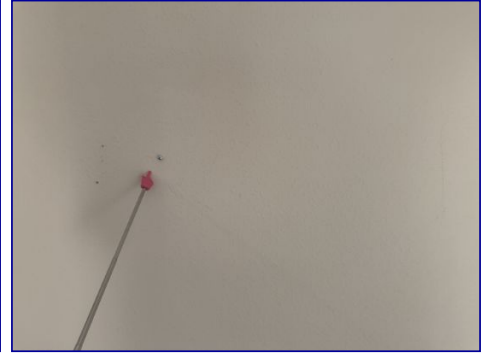
Screw Hole on Walls

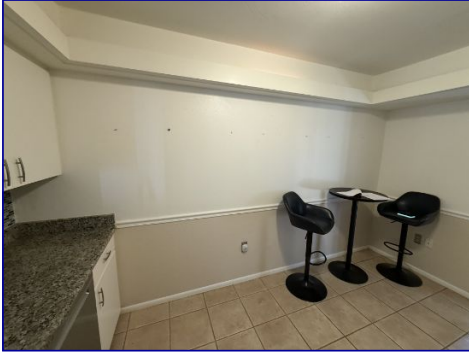
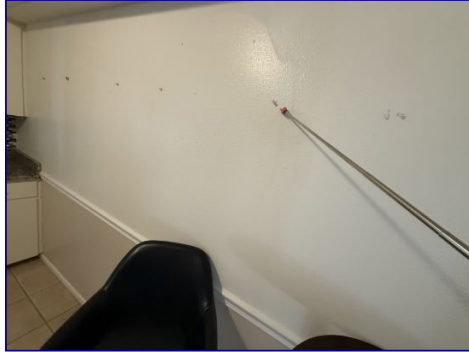
- Typical cracking present in the kitchen walls/ceiling. Recommend monitoring and repair as needed.
- Several large bolt holes.

Several Bolt Holes

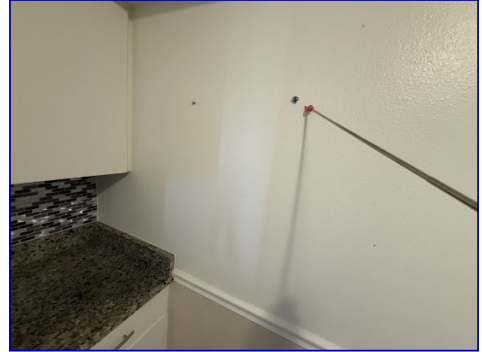
Several Bolt Holes

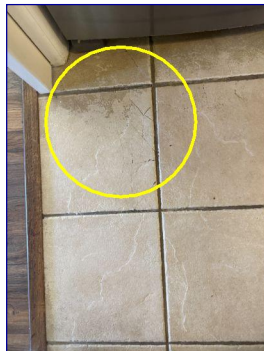
- The tile floor had some cracked/damaged tiles. Replace the tiles as needed.

Major Cracking on Tile new Frig

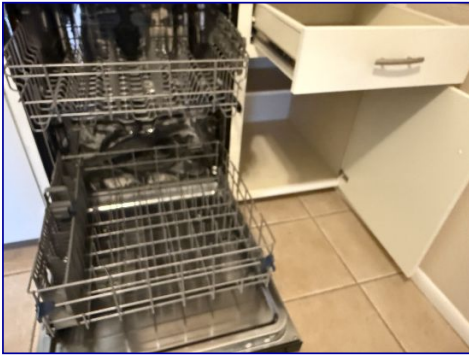
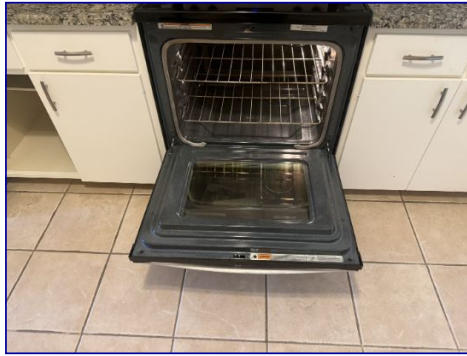
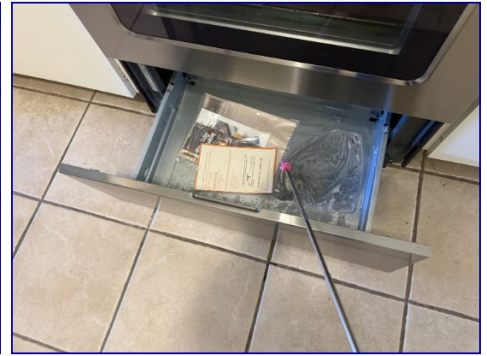
- Note: Missing broiler pan

Missing boiler pan

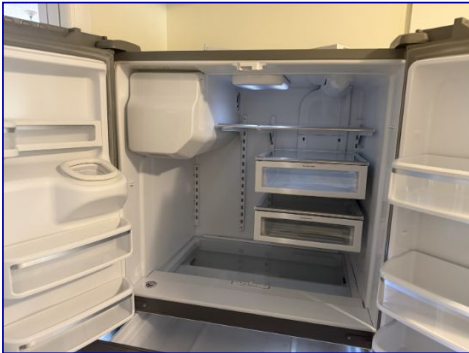
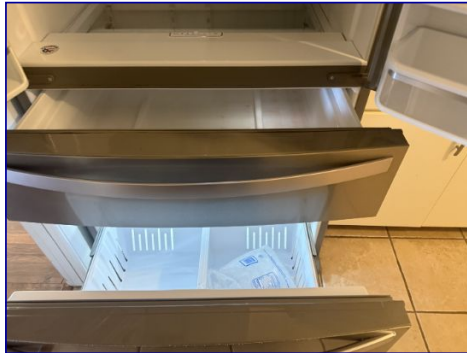
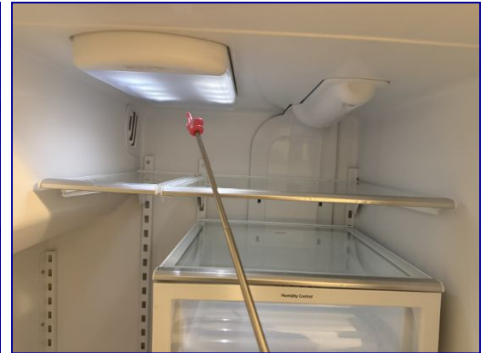
Dim Lighting

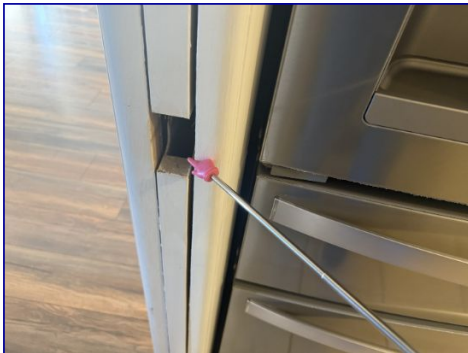
- Missing Door latch for Kitchen sliding door.

Sliding Door Missing Latch

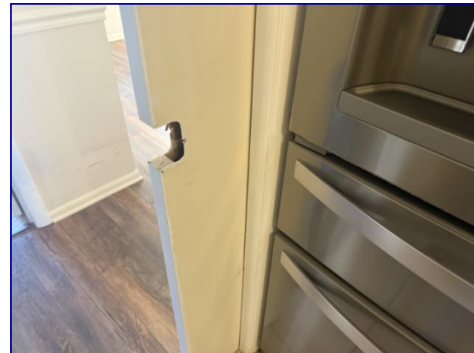
Sliding Door Missing Latch

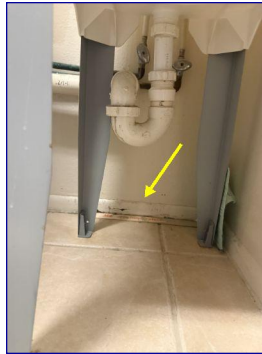
- Evidence of prior water damage along base boards

Water damage

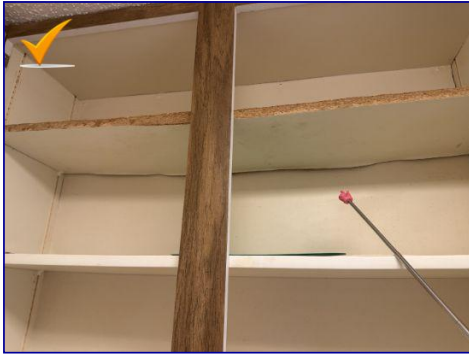
- Water Damage to some cabinet shelves

Water damage

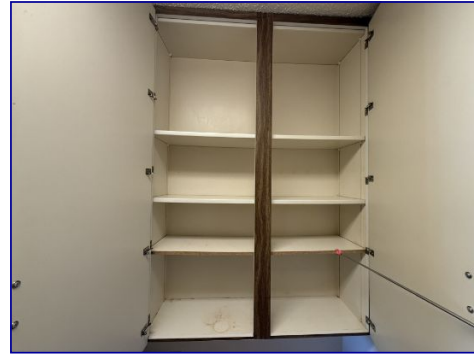
Water damage

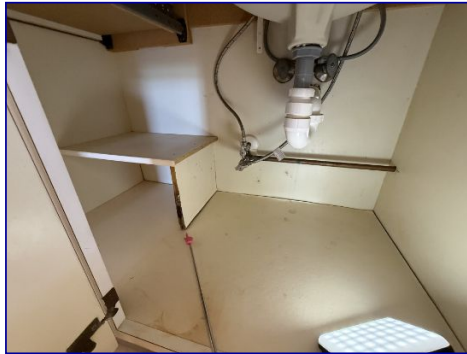
- The bathroom plumbing view.
- There was previous moisture staining and damage present under the bathroom vanity cabinet. Recommend monitoring. Repair or replace as needed.

Water damage

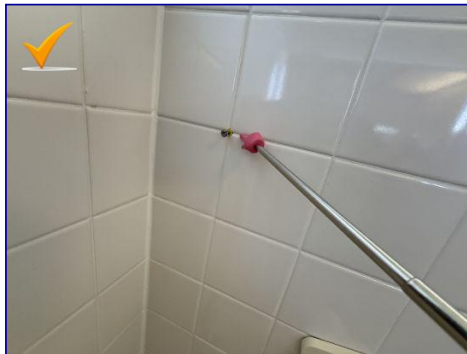
- Shower/Bathtub Area:
- Ceramic/Plastic
 - Caulk/Grout needed: Yes

Metal Unsealed Screw

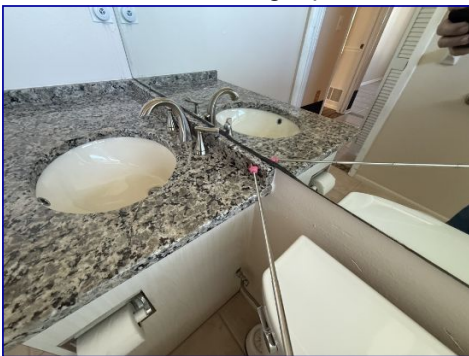
- Mirror has large chips missing
- Over head light panels broken

Very Chipped Mirror

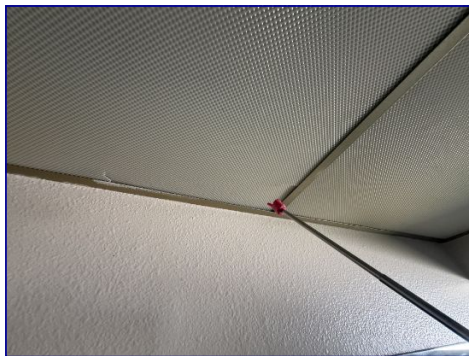
Broken over head light panel

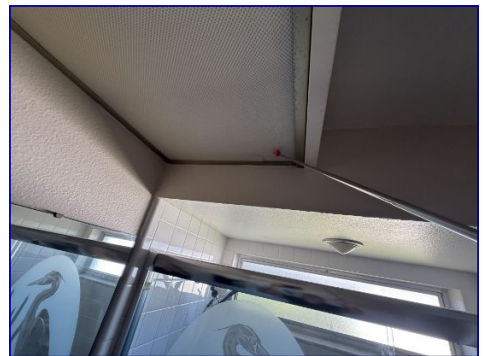
Broken over head light panel

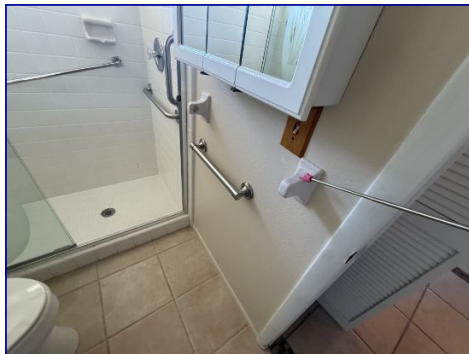
Missing towel bar

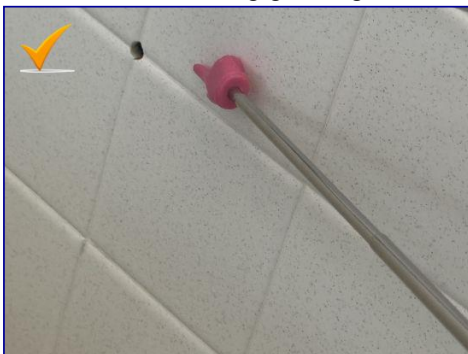
- Recommend caulking/grouting in the shower and tub area to help prevent damage from water penetration.

Unseal hole in tile wall

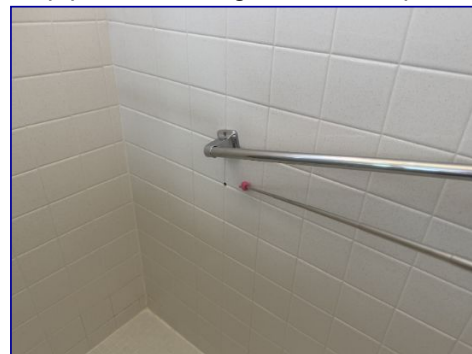
Unseal hole in tile wall

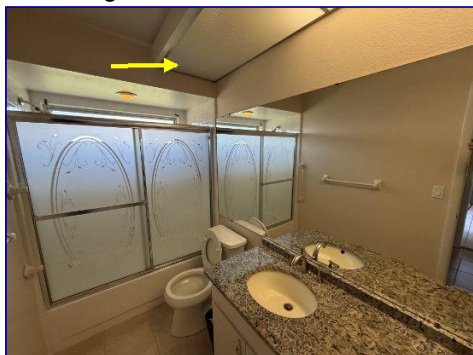
- Observations:
- Broken light panels
 - Half of light fixture not functional

Light Not Functional

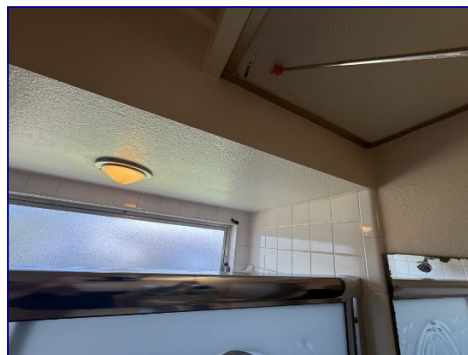
Broken Light Panel

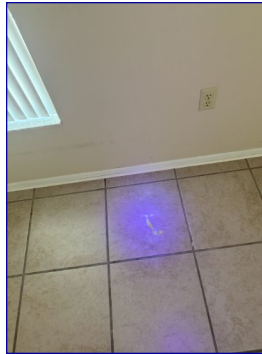
- Large UV stain found

UV Stain- Possible Pet Stain

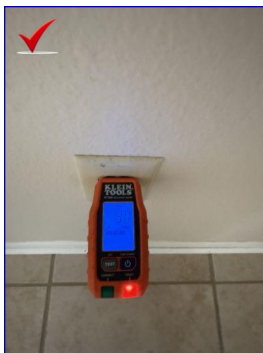
- There are loose receptacles present, which is a potential safety concern in bedroom 1. Recommend a licensed electrician repair.
- 30VDC present at outlet along west wall, which is a potential safety concern in bedroom 1. Recommend a licensed electrician repair.
- 30VDC present at outlet along west wall, which is a potential safety concern in bedroom 1. Recommend a licensed electrician repair.

Bad Connection - 30VAC

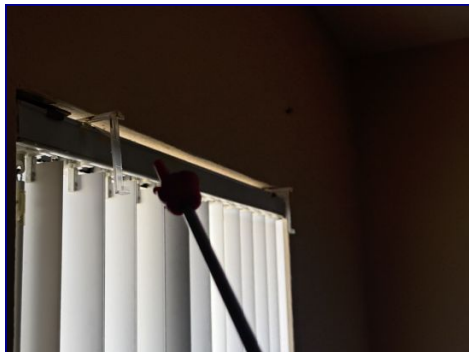
Missing part of treatment

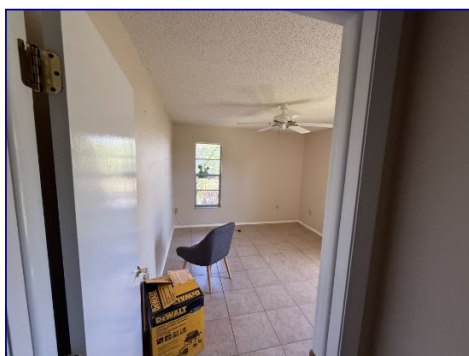
North wall

- Nail holes on wall

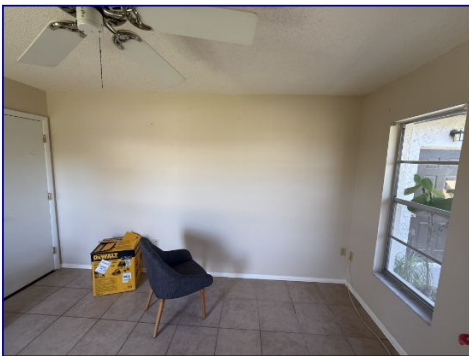
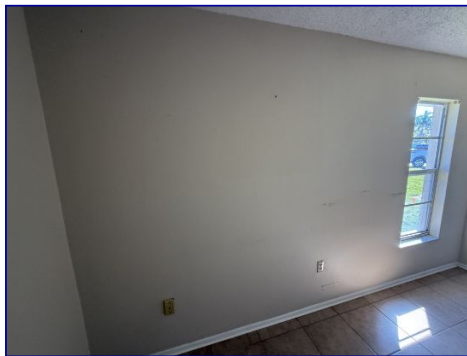
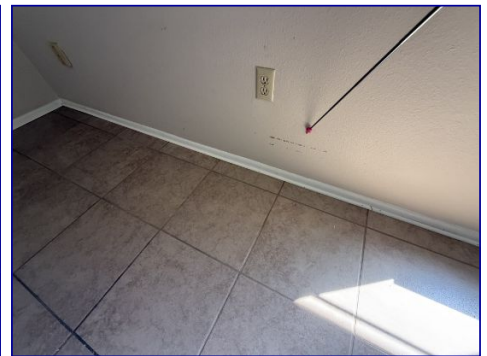
- Nail holes on wall

Damage to wall

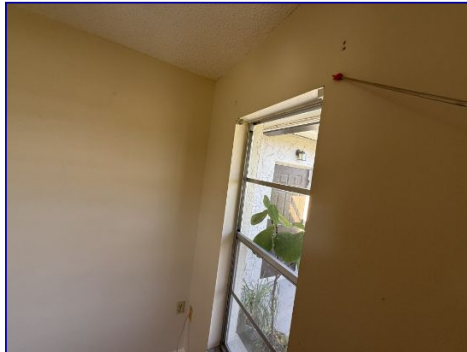
- Window/screen functional :Yes
- Window blinds present and in good condition: No

Missing all treatment and blinds
