Property Inspection Report

Patrick Casey
Casey Premier Service LLC

123 East 110 ST
Inspection Prepared For: James Smith
Agent:

Date of Inspection: 1/29/2026
Year Built: 22 Years Size: 2100
Weather: Clear

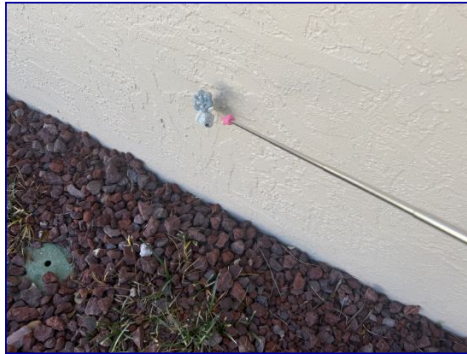
- Hose Bibs:
- No, not operable
- Observations:
- At least one hose bib is not equipped with an anti-siphon device. A possible cross-contamination can occur, which is a potential safety concern. A licensed plumber should install an anti-siphon/vacuum breaker.
 - Hose Bib on SW is not functional and capped

Not Functional and Capped SW corner
