Property Inspection Report

Patrick Casey
Casey Premier Service LLC

123 East 110 ST
Inspection Prepared For: James Smith
Agent:

Date of Inspection: 1/29/2026
Year Built: 22 Years Size: 2100
Weather: Clear

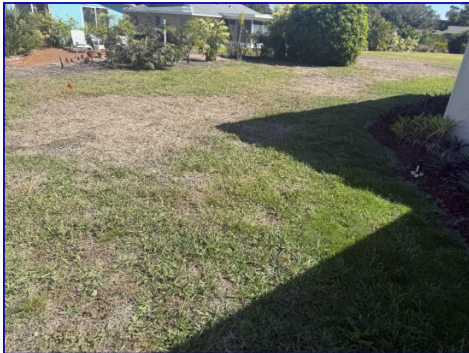
North View (Back)

- Back yard has many dead areas/
